## **APPENDIXES**

This Appendix contains prints of digital images depicting natural and cultural aspects of the project area on Kelleys Island, Ohio. The Appendix is subdivided into 4 sections which comprise the following topics:

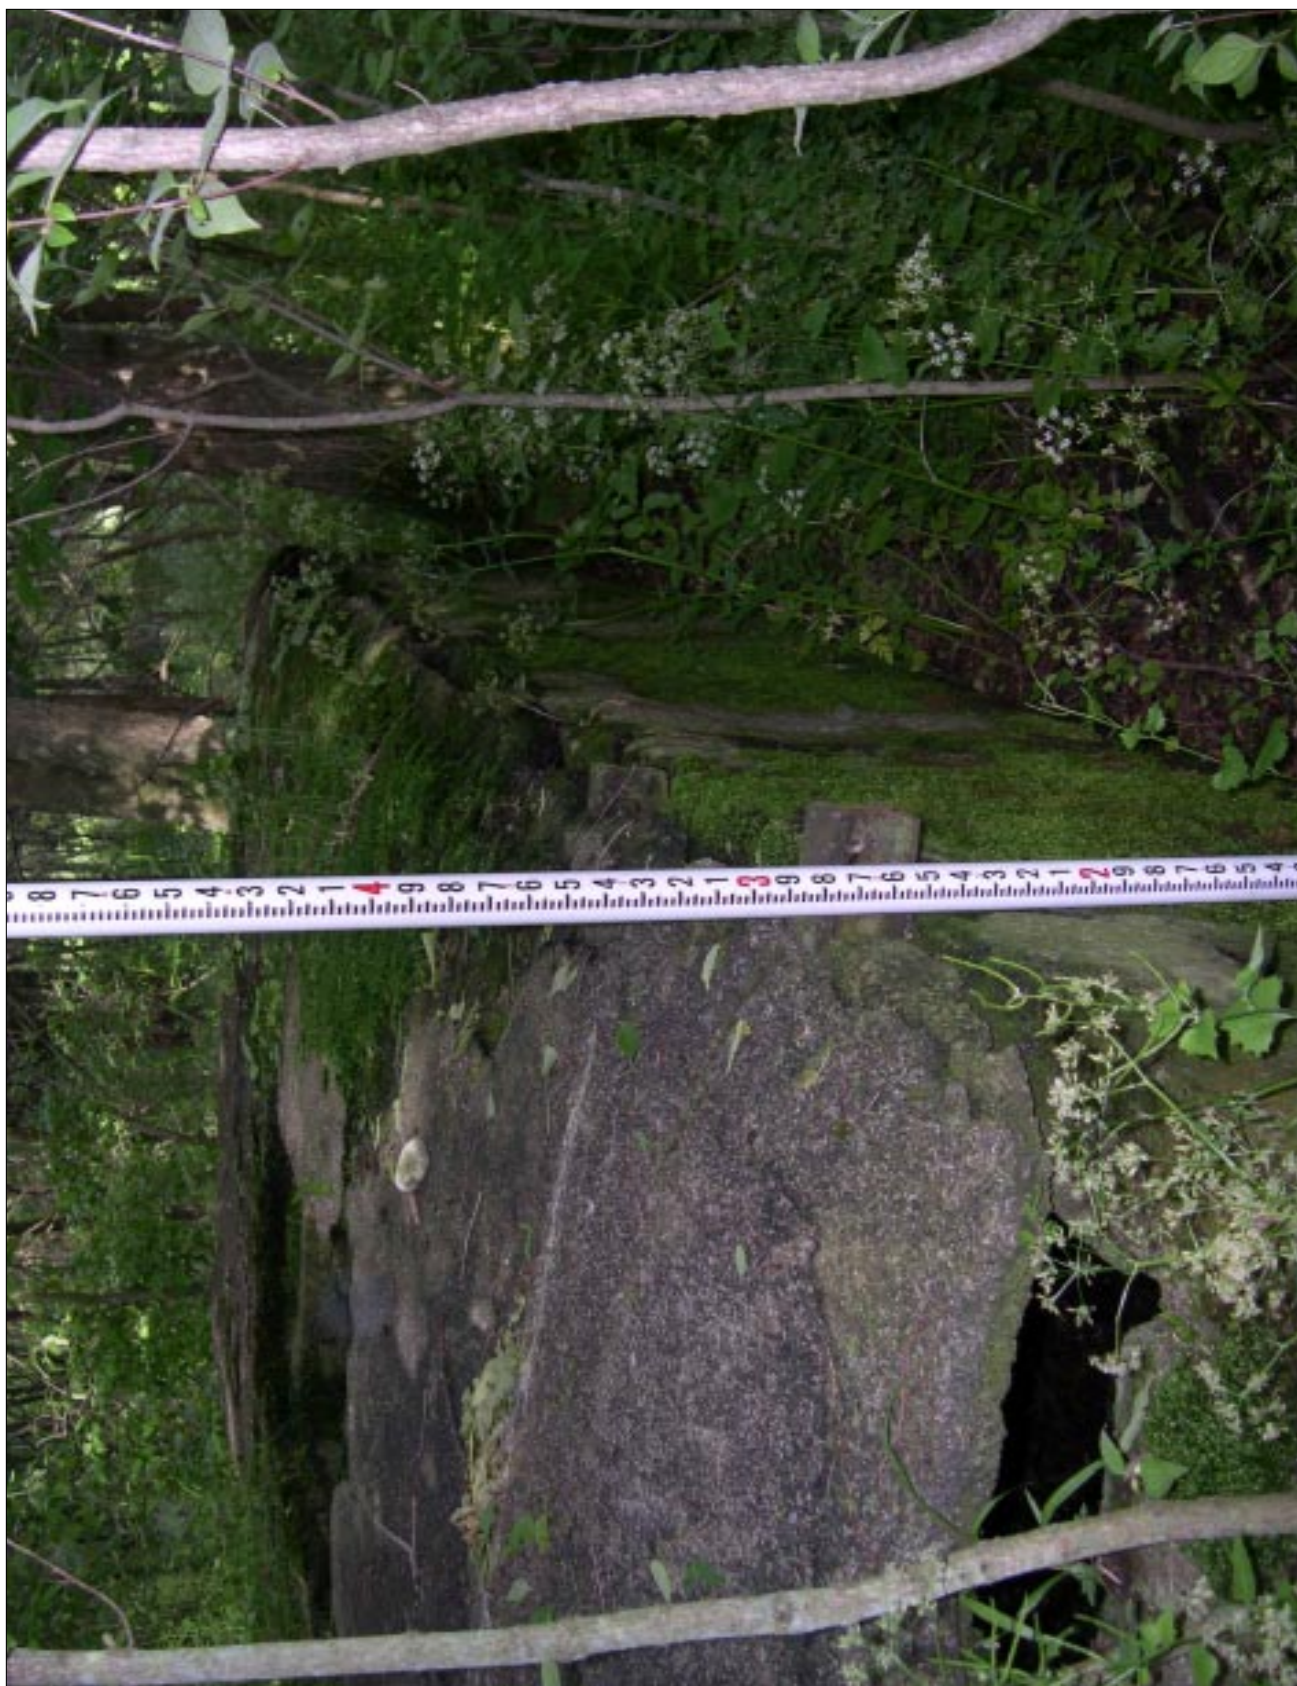
*Image IC-7. Side and cap of isolated cistern from east corner, showing narrow-gauge railroad rail used to reinforce cap; stadia pole marked in feet and tenths (May 29, 2004).*

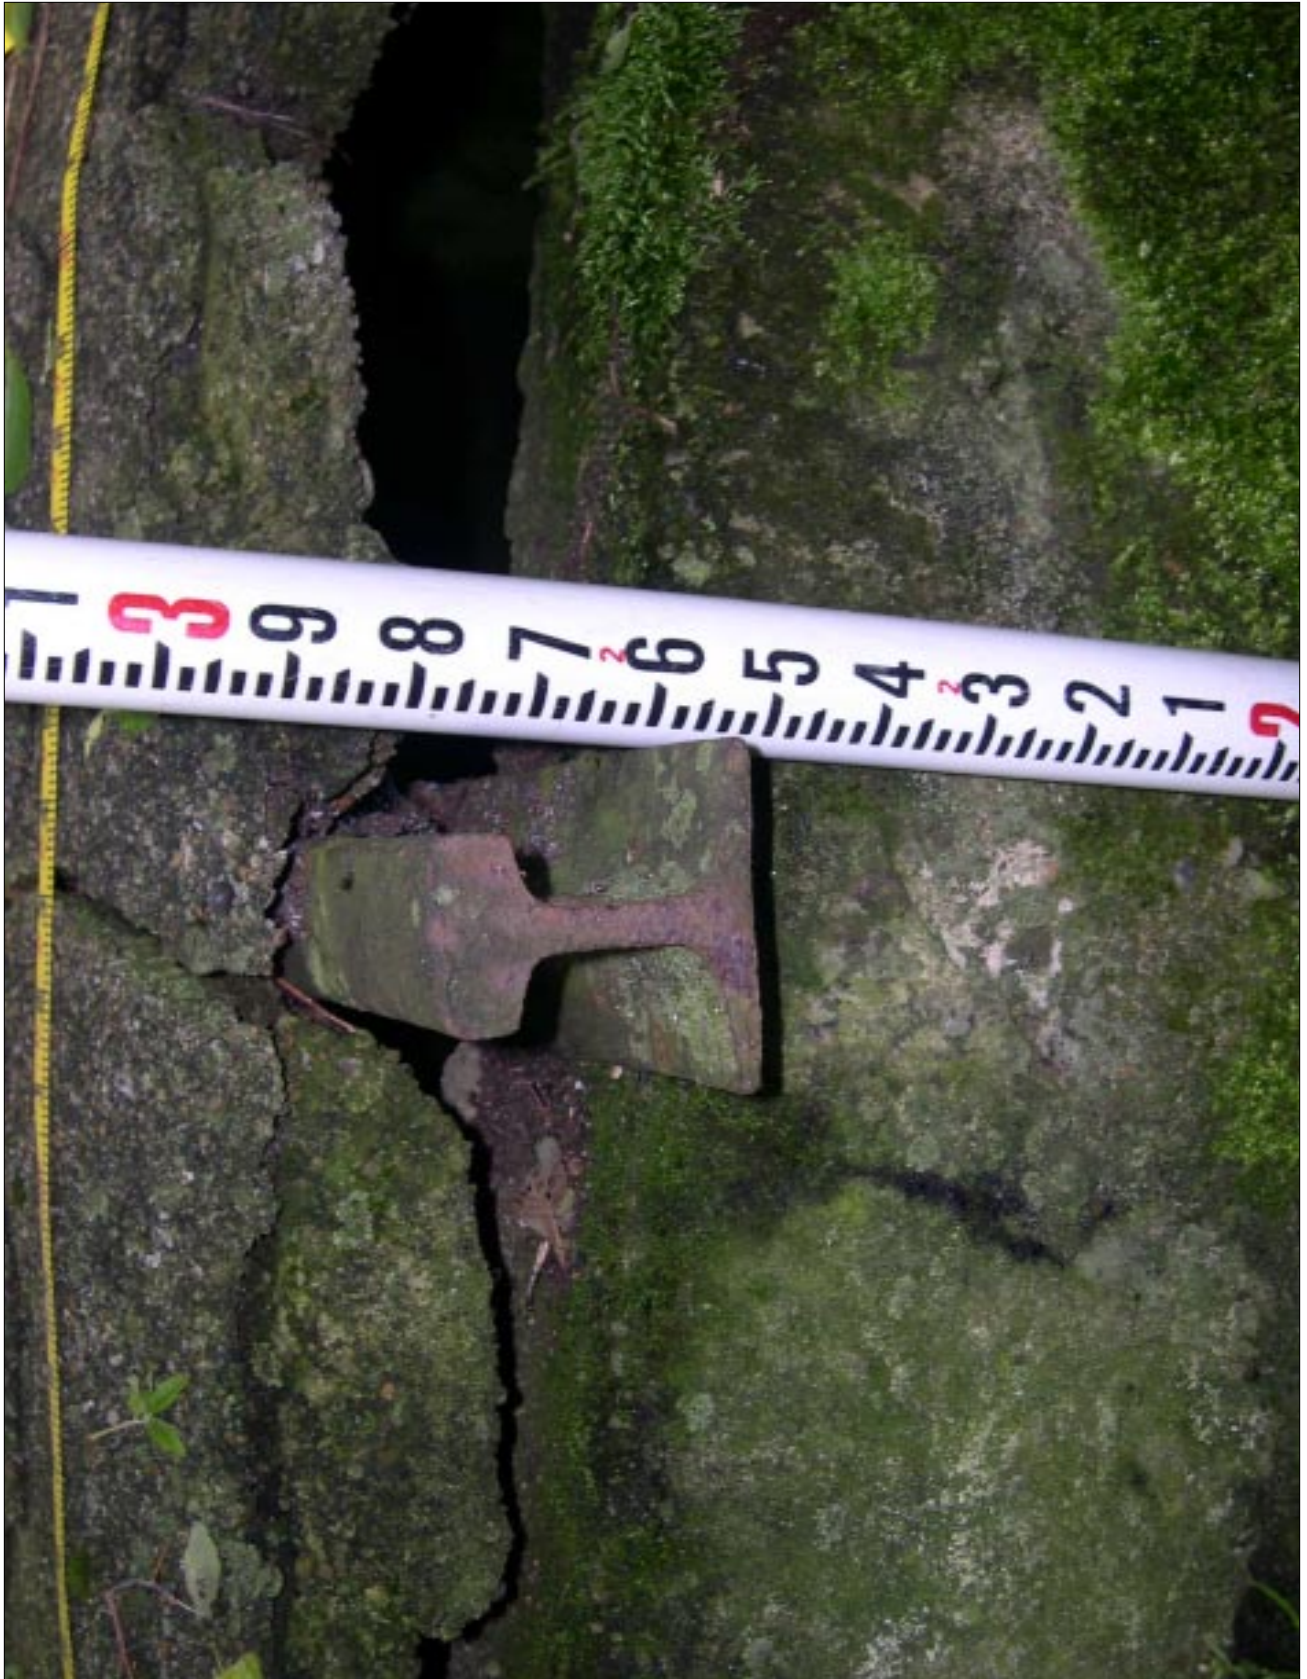
*Image IC-8. Close-up view of narrow-gauge railroad rail used to reinforce cistern cap; stadia pole marked in feet and tenths (May 29, 2004).*

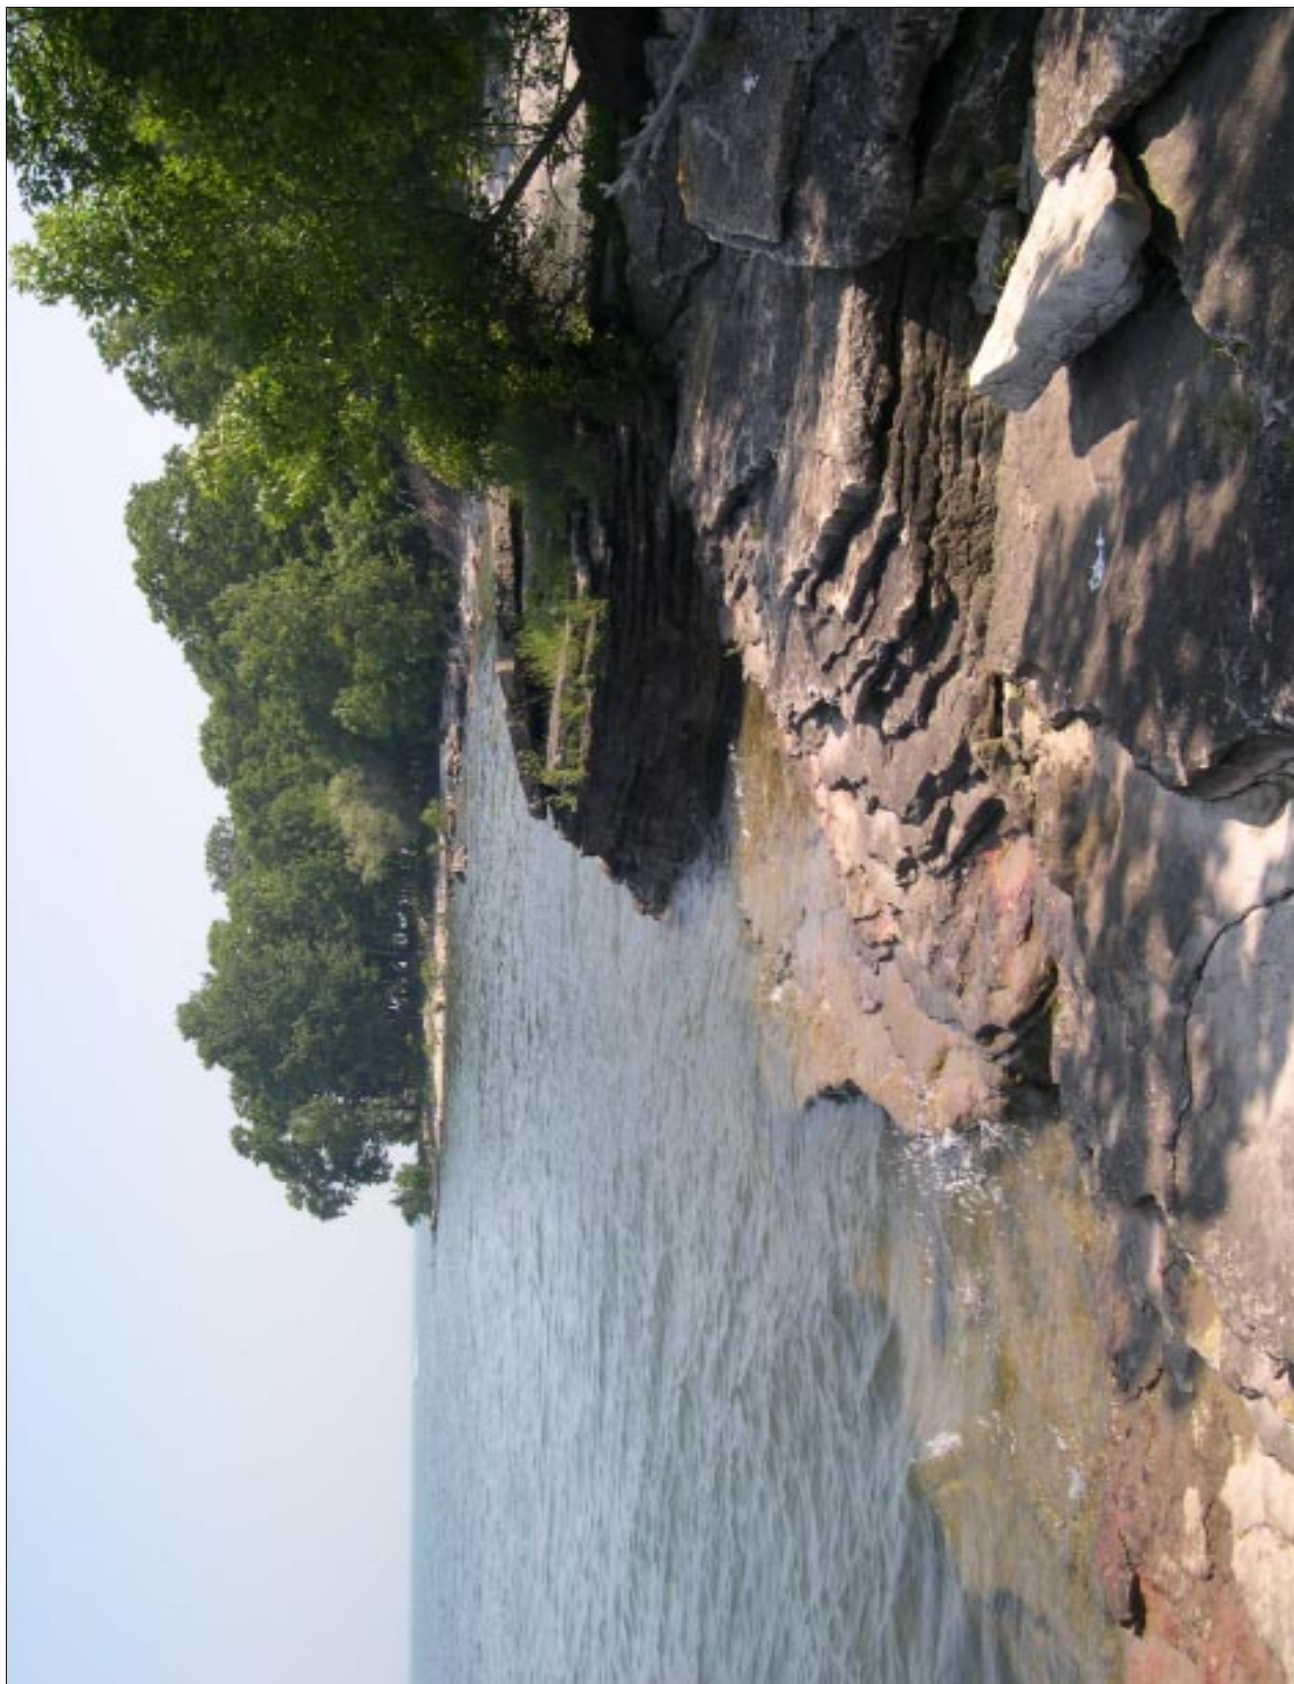
*Image SH-1. Shoreline view to the northeast from the northern edge of the Predevelopment, Ltd. tract; note limestone bedrock ledges (June 8, 2004).*

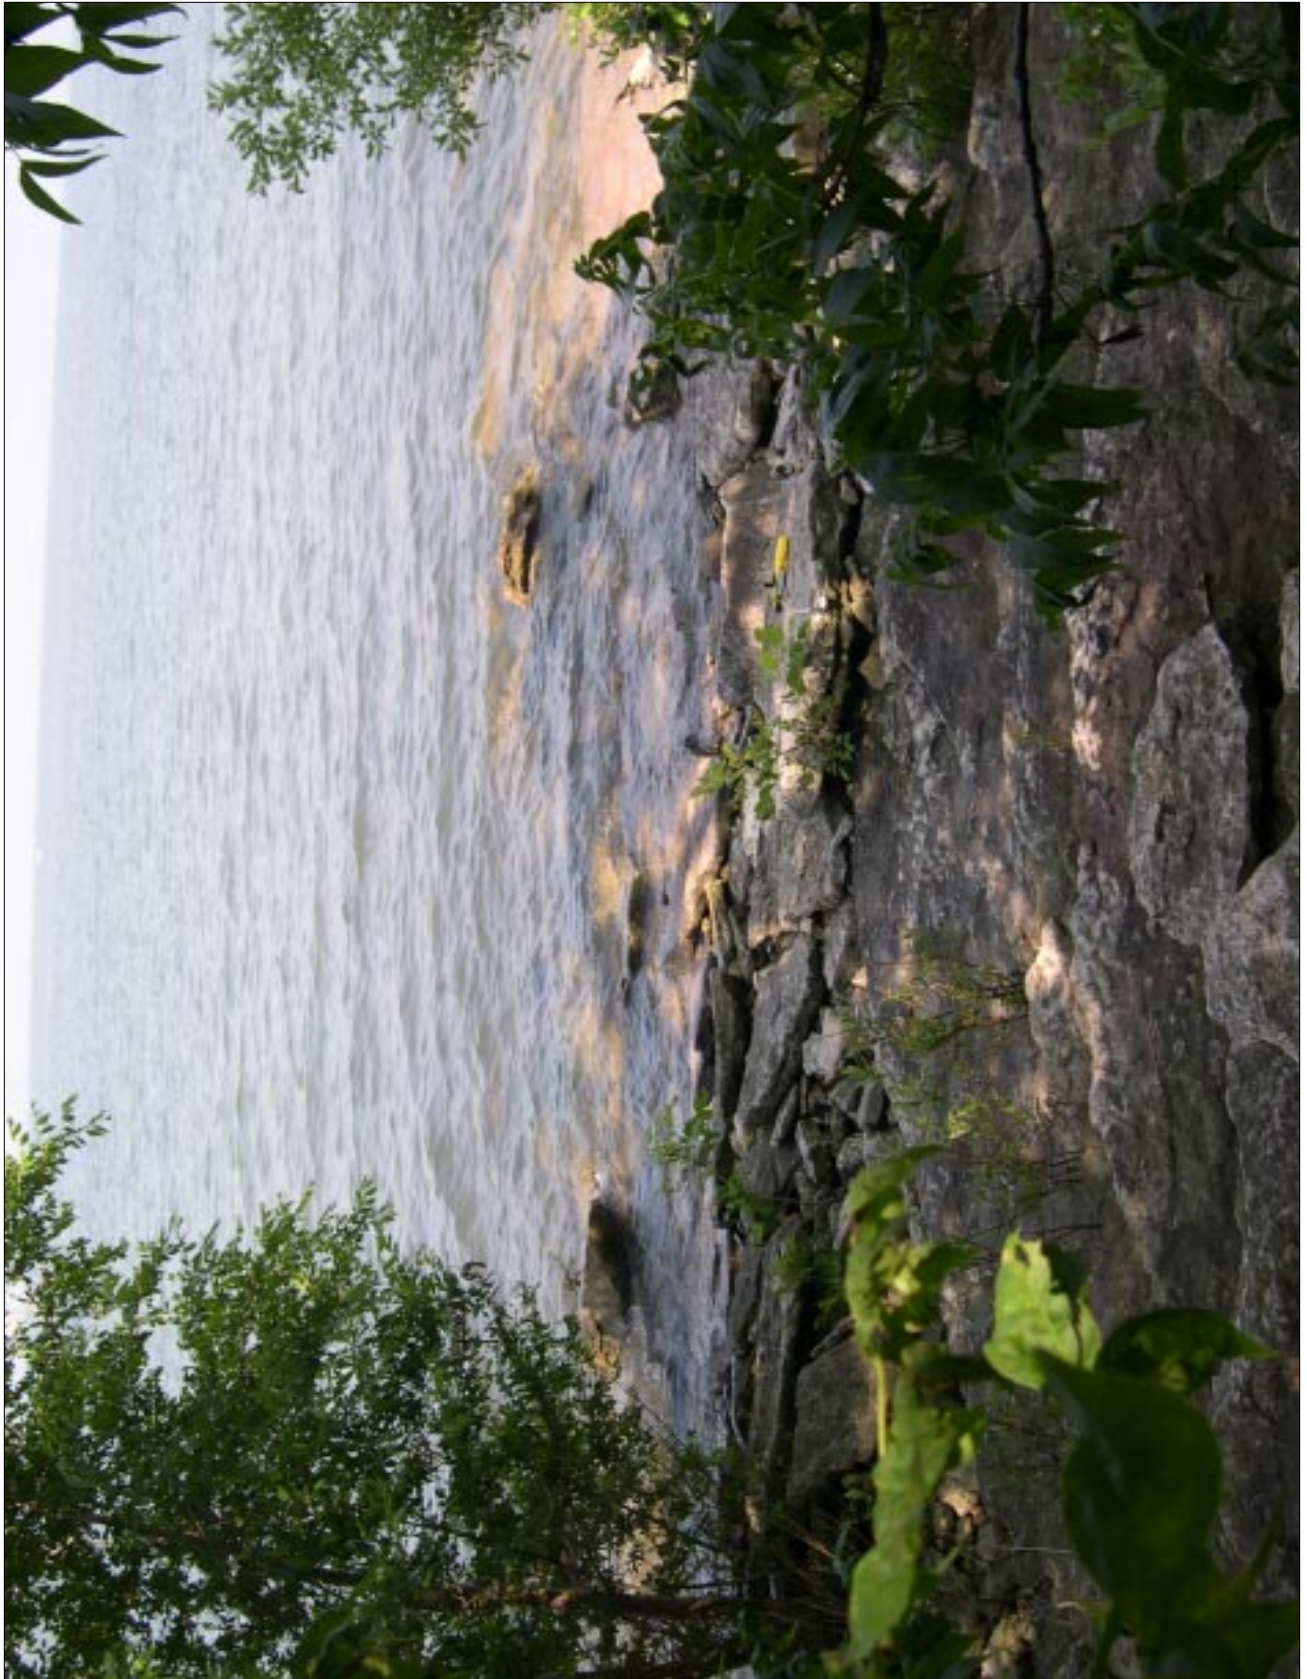
*Image SH-2. Shoreline view to the west along transect S; note nearshore bottom composed of bedrock (June 8, 2004).*

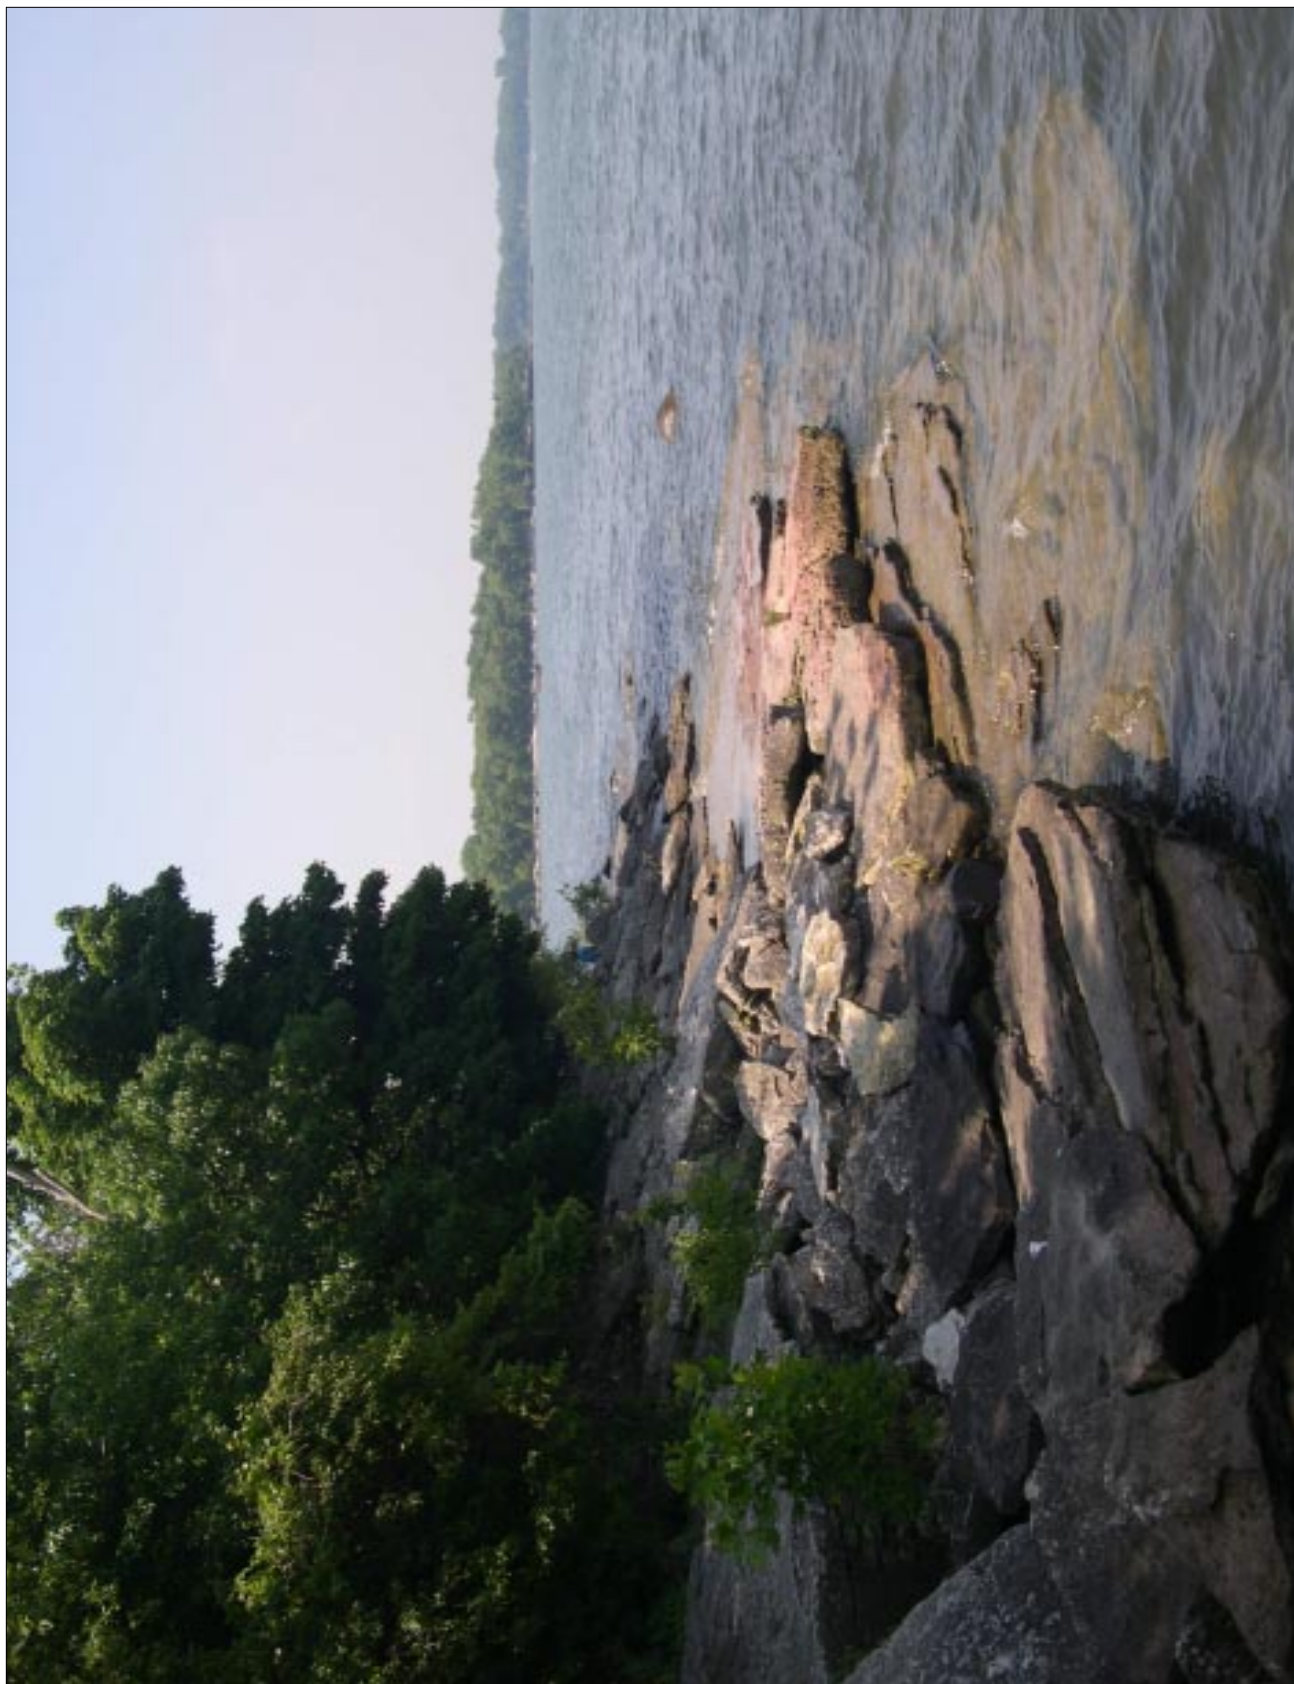
*Image SH-3. Shoreline view to the south from transect S, showing broad embayment along the Predevelopment, Ltd. tract (June 8, 2004).*

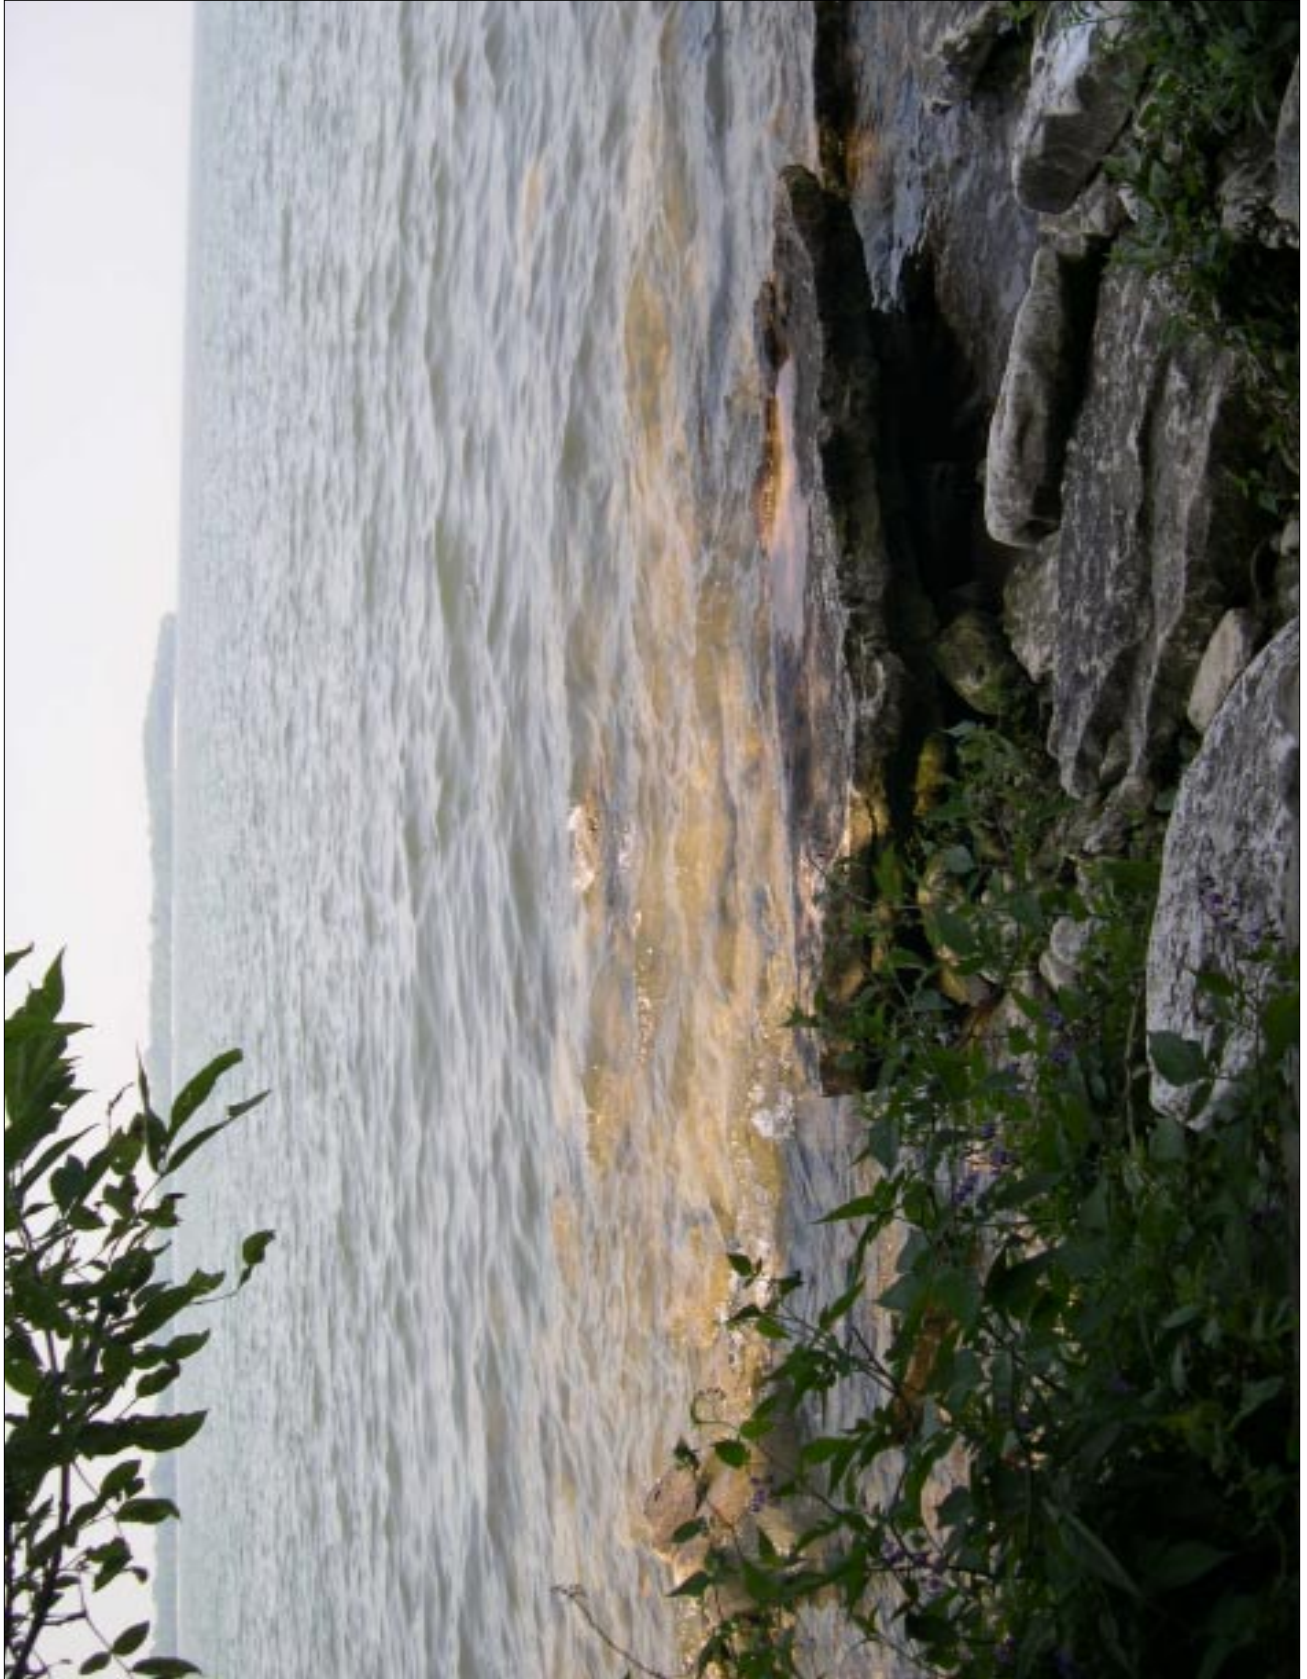
*Image SH-4. Shoreline view to the west along transect R; note submerged bedrock shelf (June 8, 2004).*

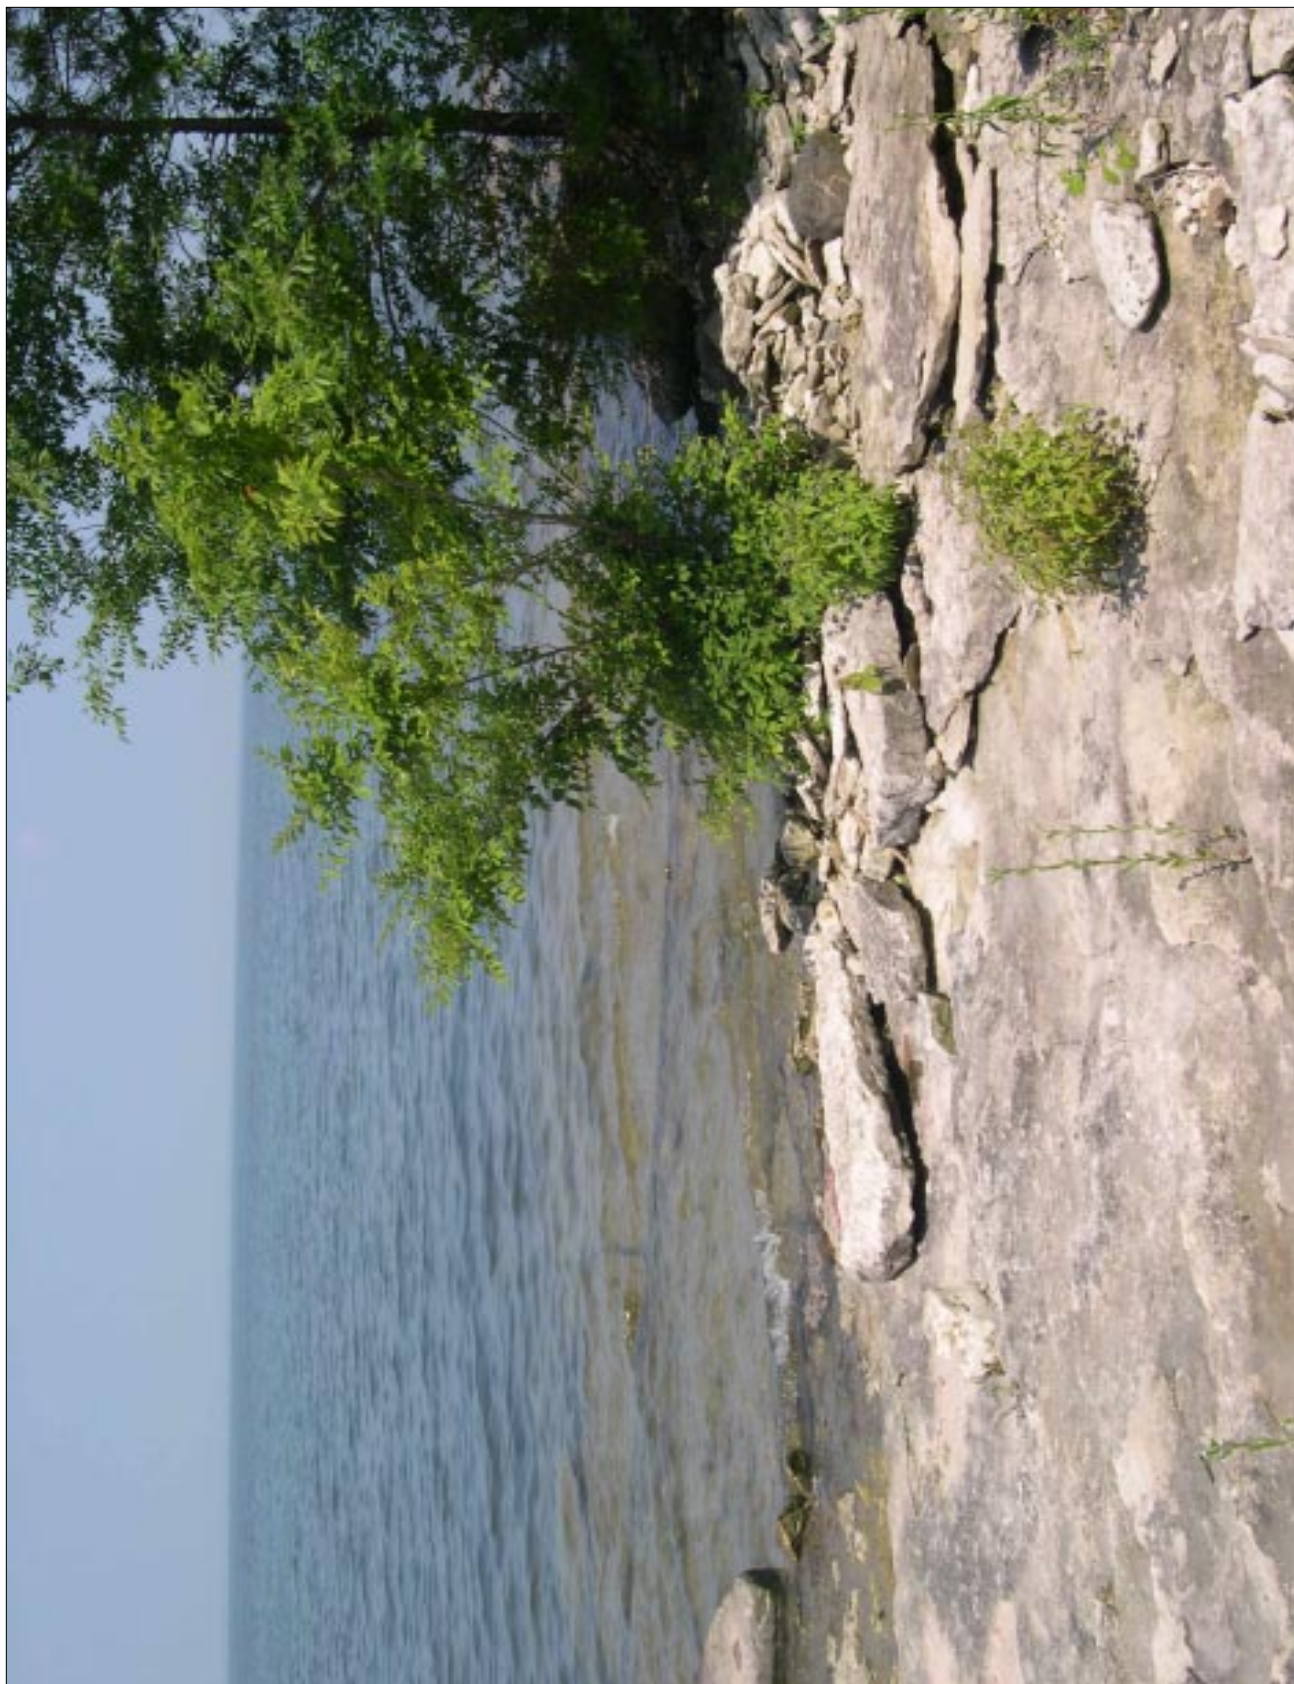
*Image SH-5. Shoreline view to the west along transect P; note bedrock plain on the shore that extends underwater (June 8, 2004).*

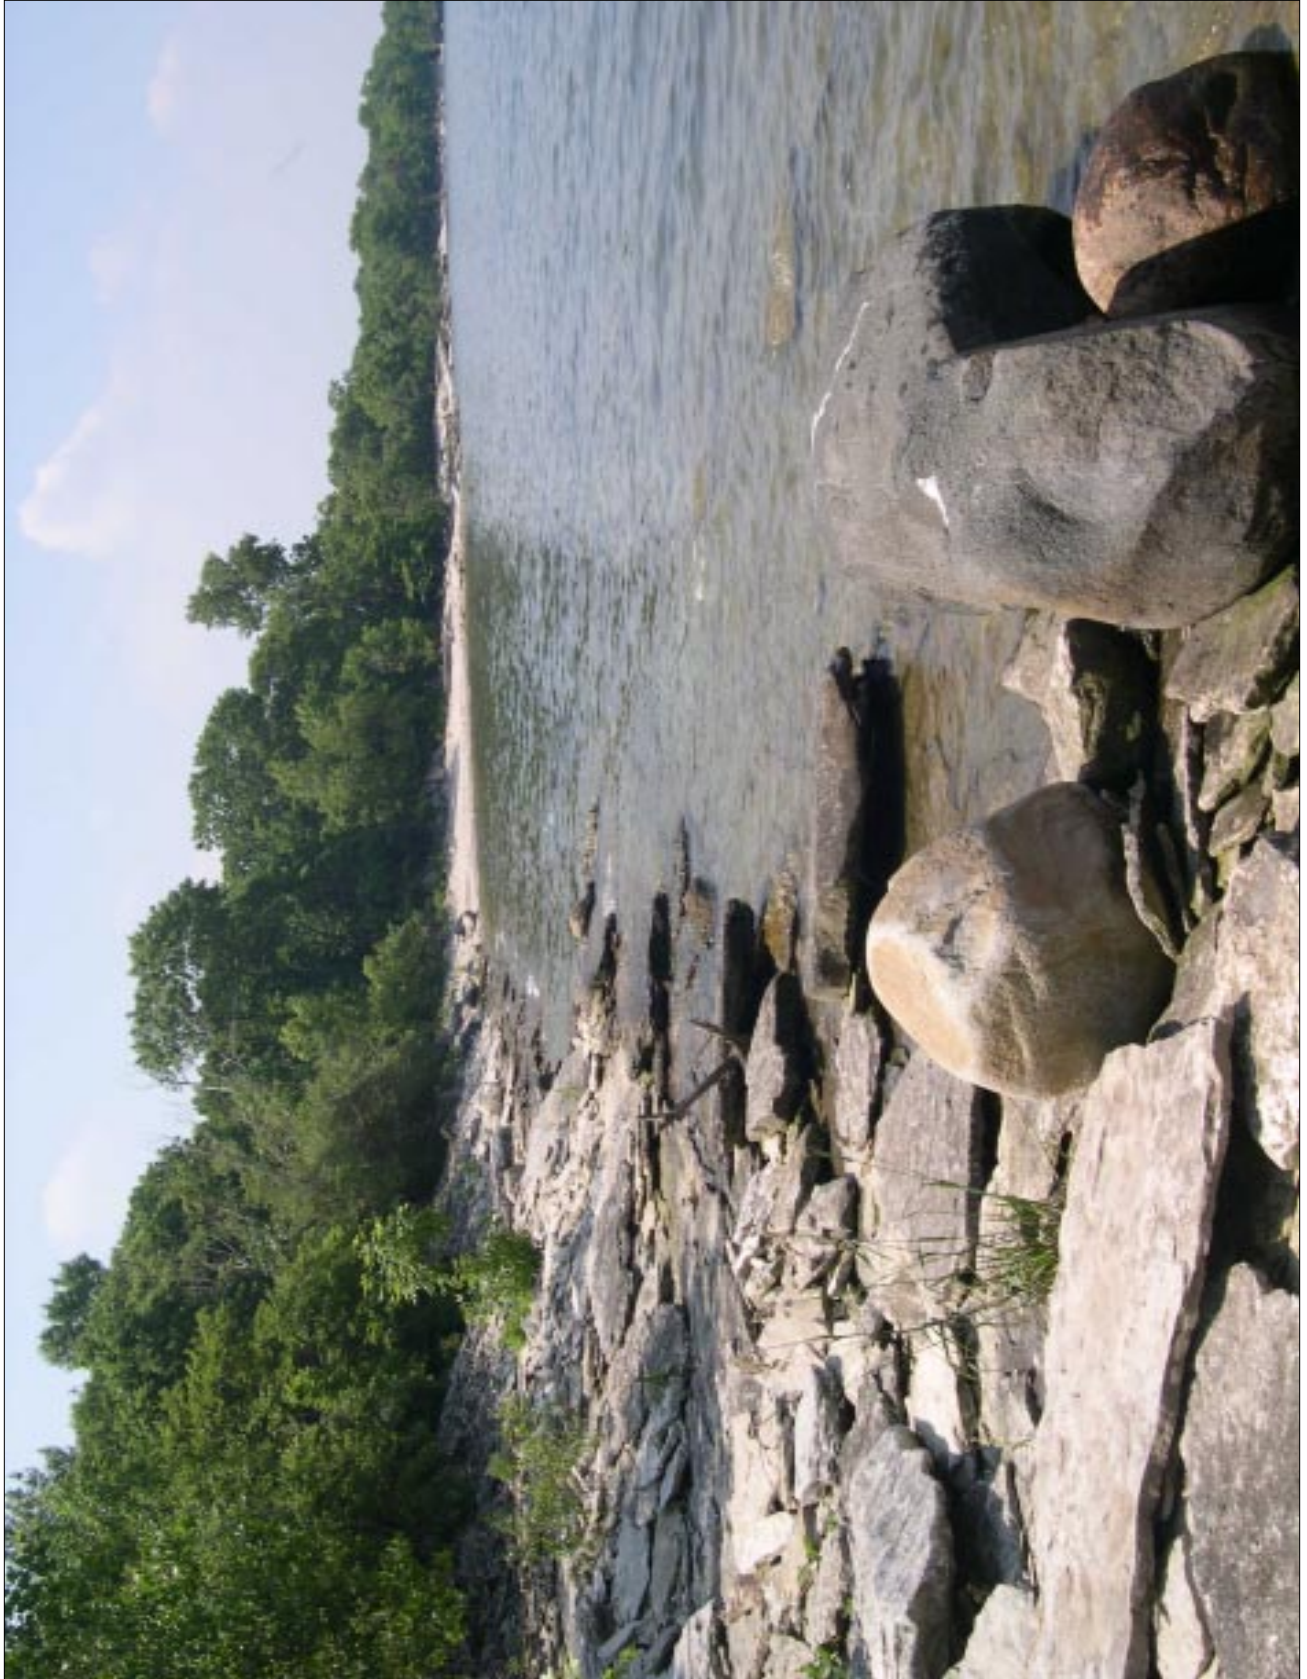
*Image SH-6. Shoreline view to the south from transect O; note large glacial boulders and limestone slabs at water's edge of embayment (June 8, 2004).*

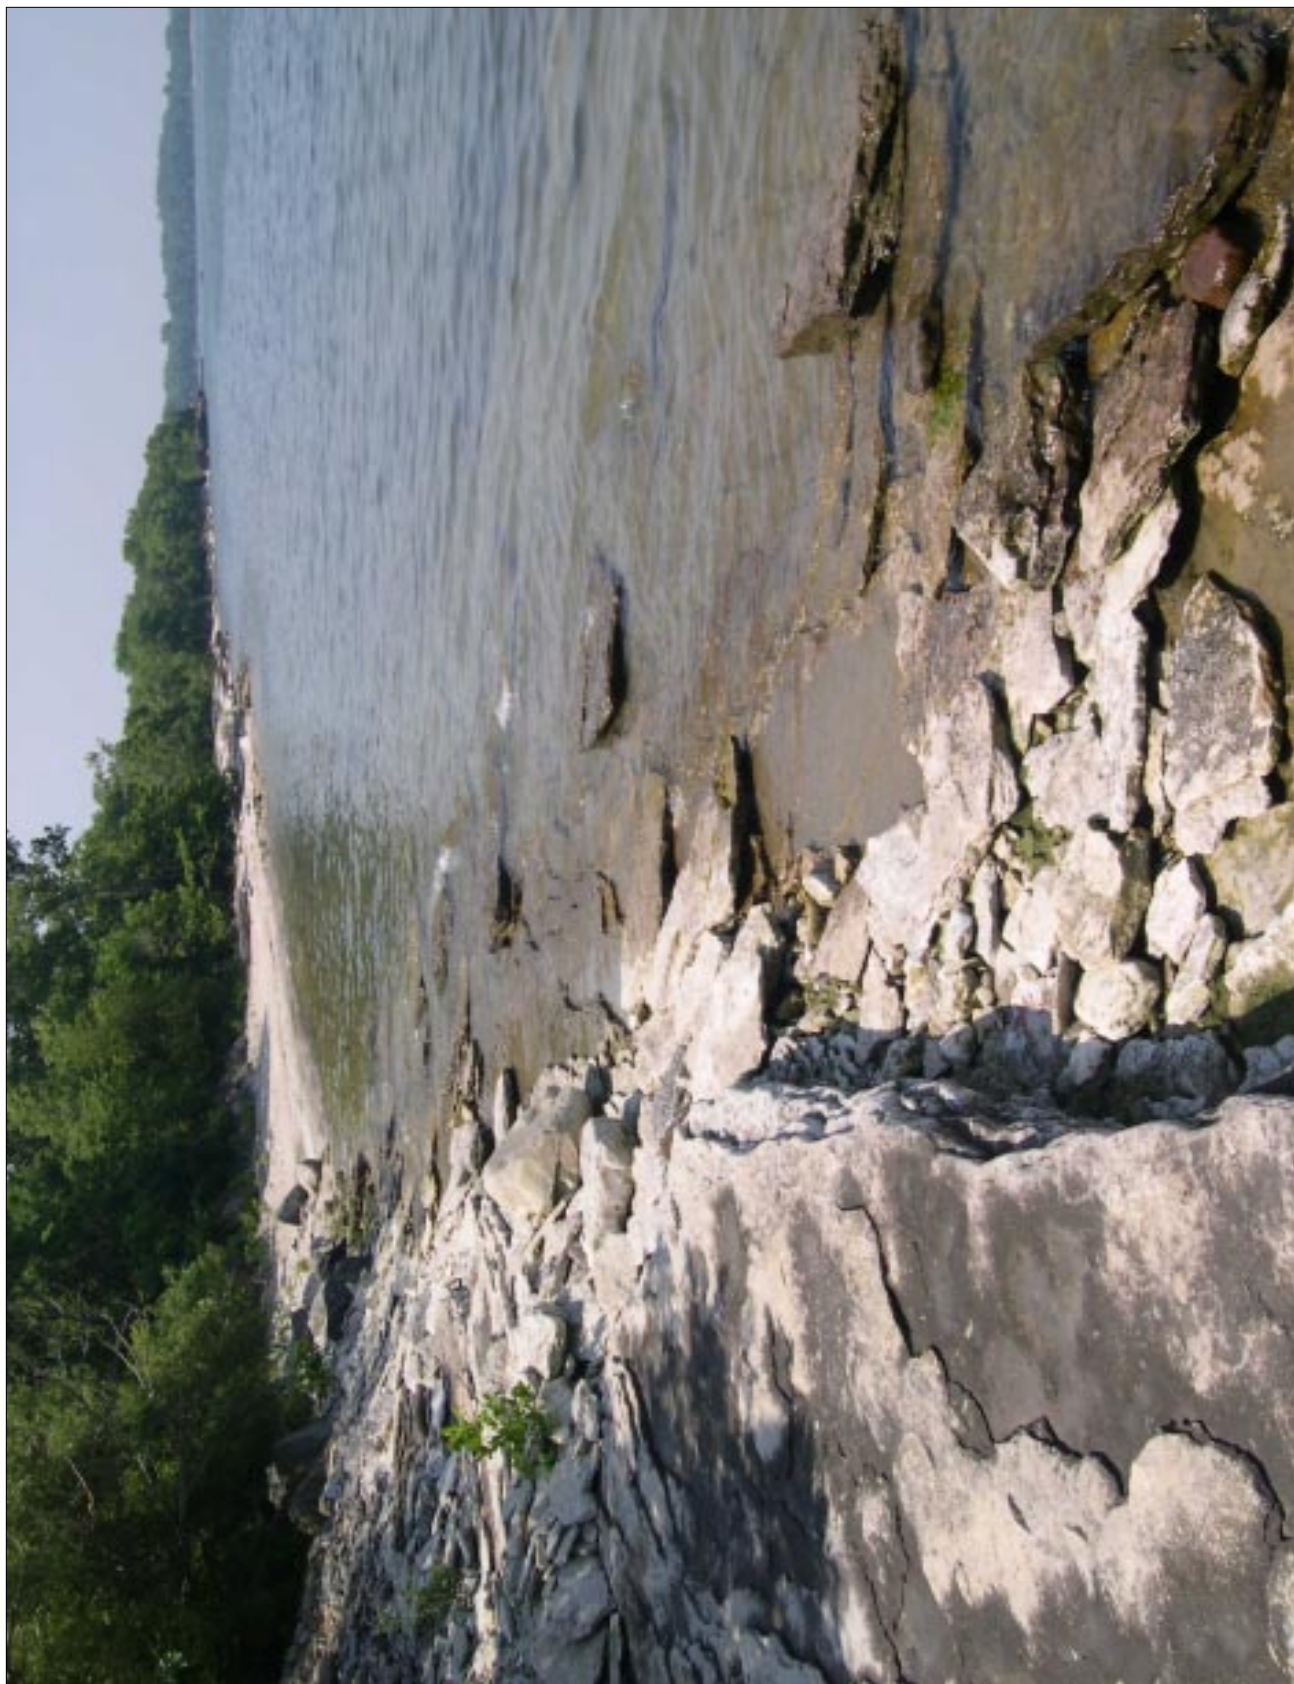
*Image SH-7. Shoreline view to the south from transect N; note limestone rubble beach in foreground and offshore bedrock shelf (June 8, 2004).*

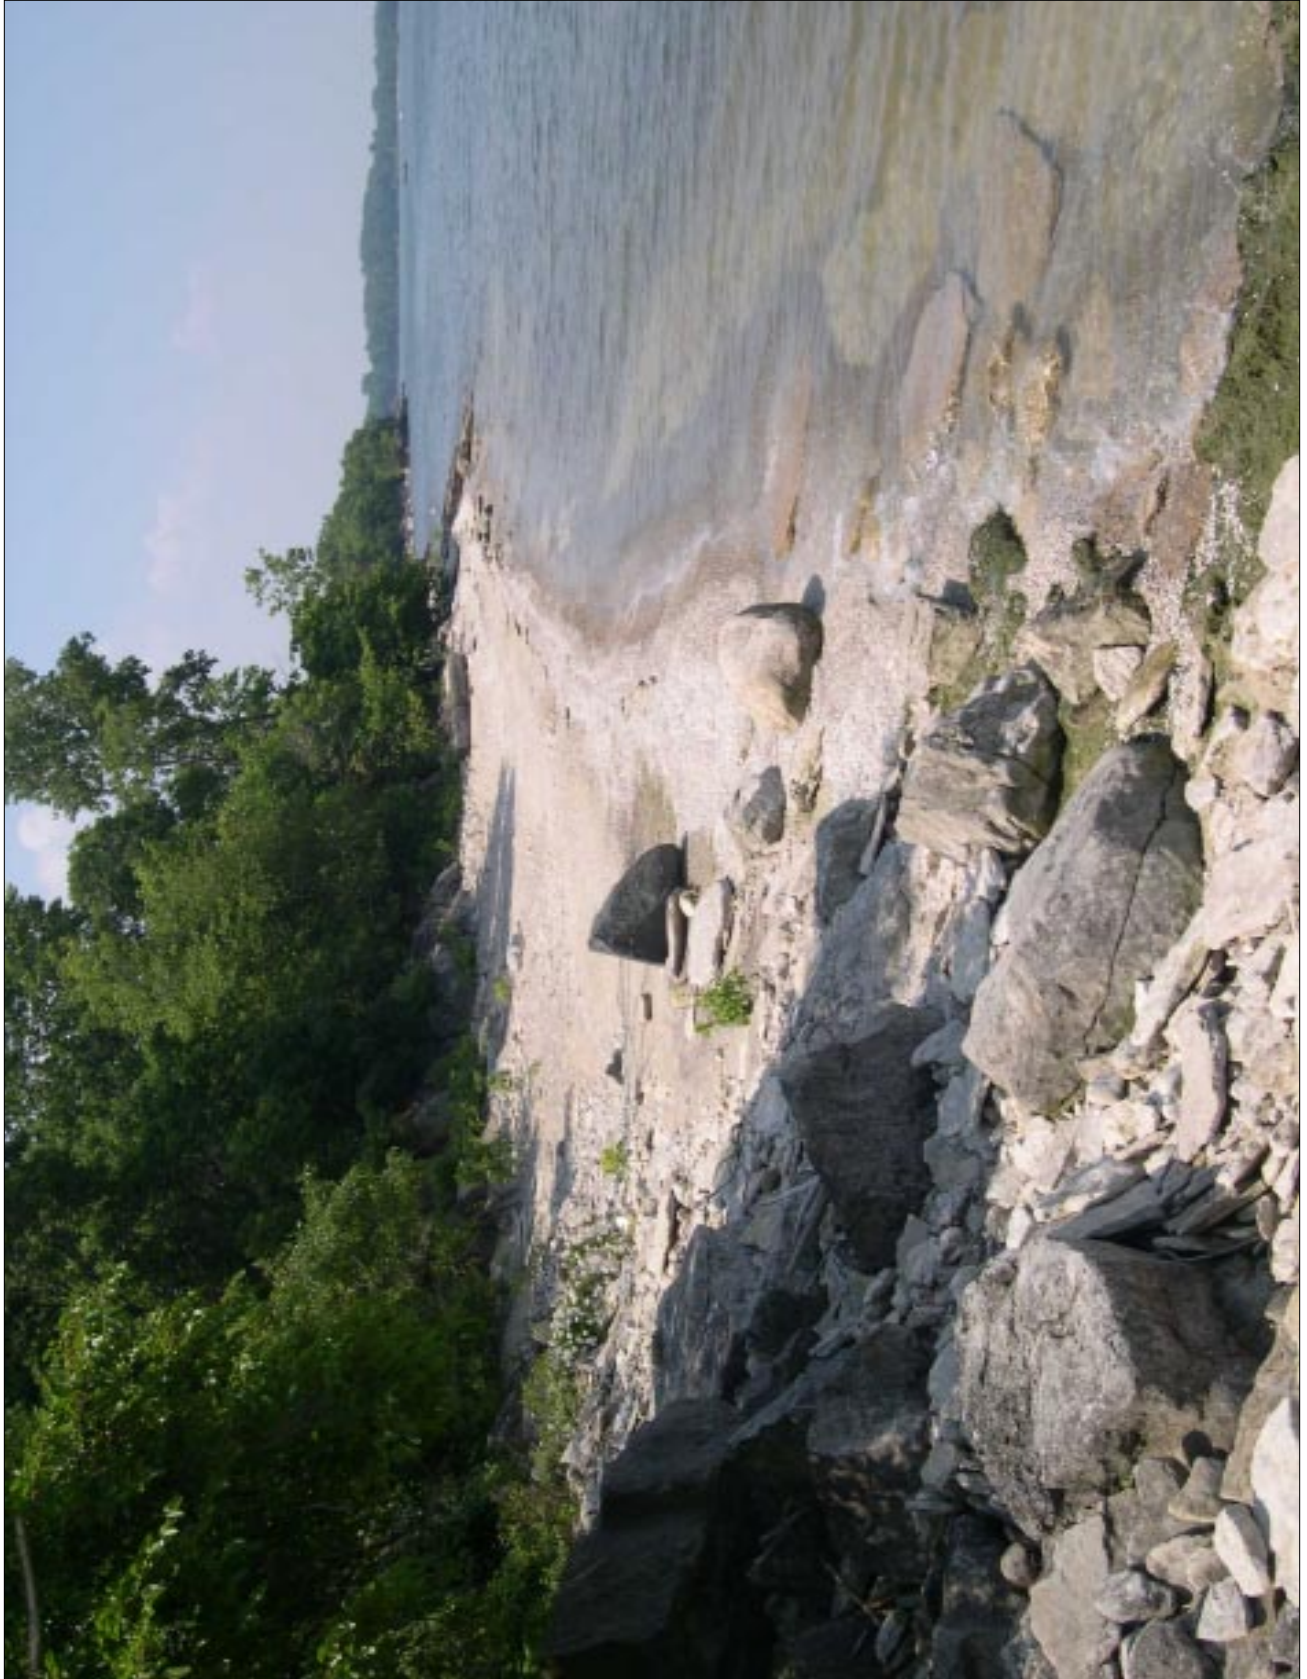
*Image SH-8. Shoreline view to the southwest from transect M; note rubble beach grading to sand near the center of the embayment (June 8, 2004).*
